# APPLICATION NOTE

**Product Family: Productivity 3000**

**Number: AN-P3-001**

**Subject: ASCII communication differences  
before and after V1.0.9.23**

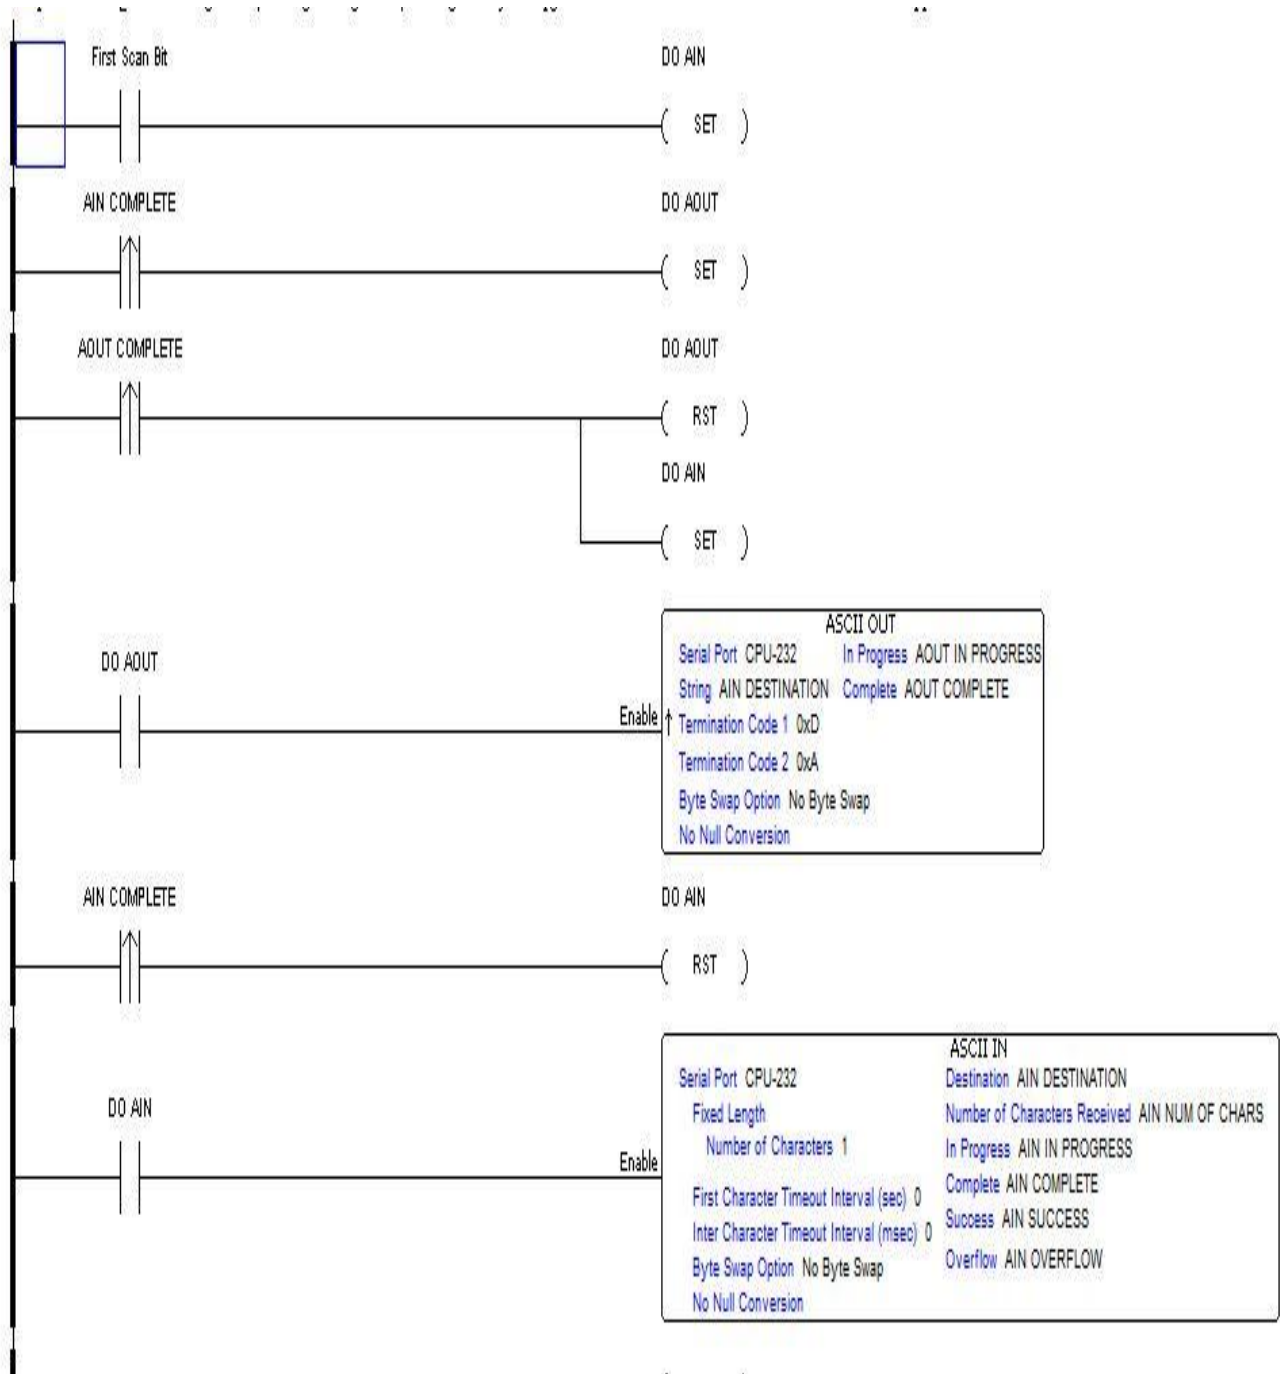
Because of this behavior the ASCII In and ASCII Out could both be enabled in the same program scan and the ASCII Out would buffer the data until a scan was made and the ASCII In was not enabled and data would be sent. Therefore it was not required to interlock the ASCII In and ASCII Out instructions. This was ok unless it was several scans until the ASCII In was not enabled and then it would result in buffer or data issues. In the new firmware the ASCII In and ASCII Out instruction must be interlocked to avoid them being enabled on the same program scan since the ASCII Out can no longer buffer data. If they are not interlocked and the ASCII In is always active the ASCII Out will never send data.

This example logic will work with firmware 1.0.9.23, but not firmware starting with 1.0.10.20:

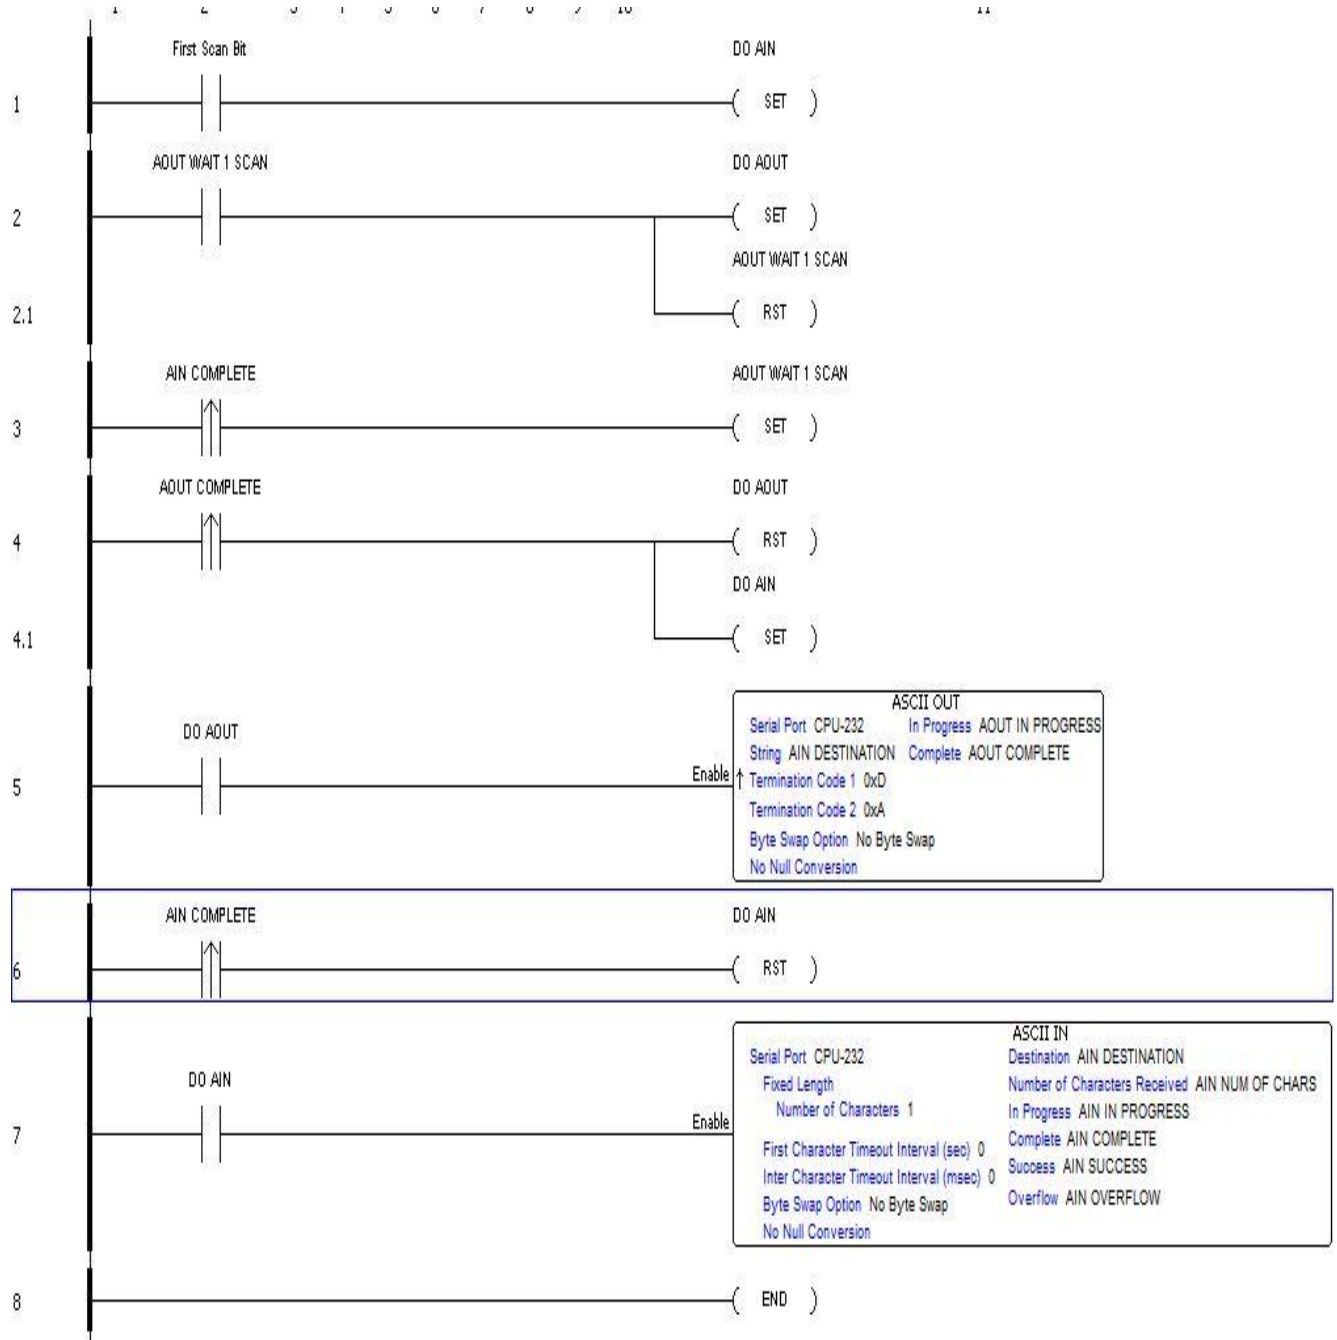
This Logic will work with any firmware:

**The key to the instructions working after the firmware change is the ASCII In and ASCII Out instructions must be programmed not to be enabled on the same scan.**
