# Product Advisory

**Product Family:** Productivity Series  
**Part Numbers:** P3-03B, P3-05B, P3-08B, P3-11B  
**Subject:** Productivity3000 base compatibility

**Number:** PA-PK-015  
**Date Issued:** 1/24/2018  
**Revision:** Rev. A

**Notice** New Productivity3000 bases require a CPU and P3-RS/RX firmware update for compatibility.

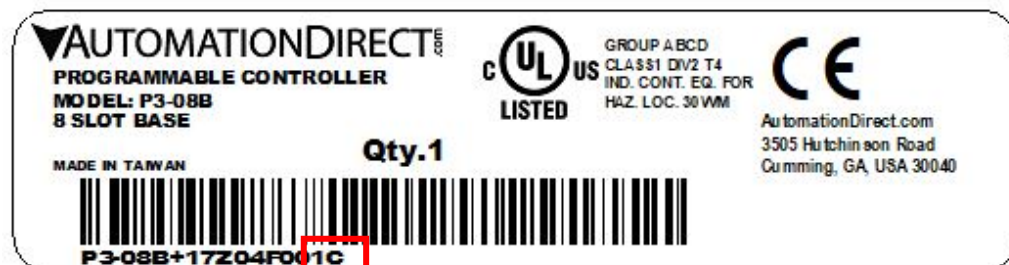
**Problem Hardware Revision**

**Description of Problem** Components on the base backplane had to be replaced due to obsolescence. This redesigned base requires a CPU firmware upgrade in order to remain compatible with existing hardware (see table below for details). All four base part numbers are affected, but will be introduced into shipments at various times based on stock levels of existing inventory. The first part number to be impacted will be the P3-08B. New revision hardware for this part will begin shipping from AutomationDirect in January-2018. Other base part numbers will follow.

**Determining** You can look at the module label to determine the hardware revision number. For example, this label indicates a Rev. C model P3-08B base, so the CPU requires an upgrade to firmware version v1.1.15.111, and a P3-RS/RX remote module requires an upgrade to firmware version 1.1.15.109.

**Symptoms** If a user configures a system with a new base and a CPU or RS/RX with old firmware, they will get a module missing error in slots with intelligent modules, after going into RUN. (Intelligent modules = P3- SCM, P3-HSI, P3-HSO)

**Solution for Problem** Upgrade the CPU firmware to version 1.1.15.111 or later and the P3-RS/RX remote module firmware to version 1.1.15.109.
